# PROPERTY INFO PACK

## 415 BREEZES ROAD, ARANUI

## **Earthquake Assessment of Property at 415 Breezes Road, Bexley, Christchurch - Site observation dated 8 October 2010**

## **EARTHQUAKE DAMAGE PHOTOS**

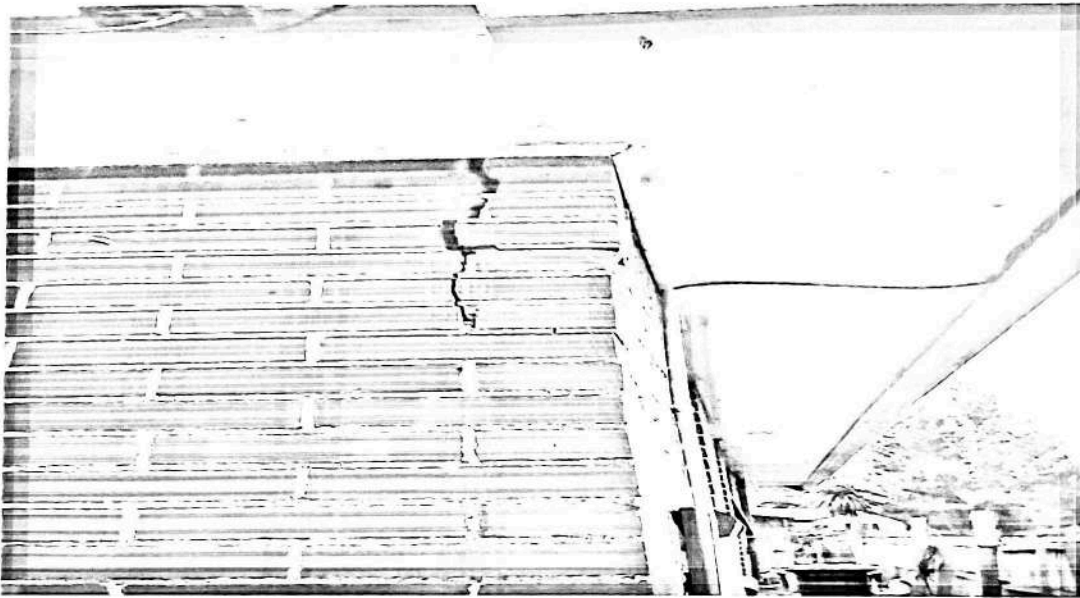
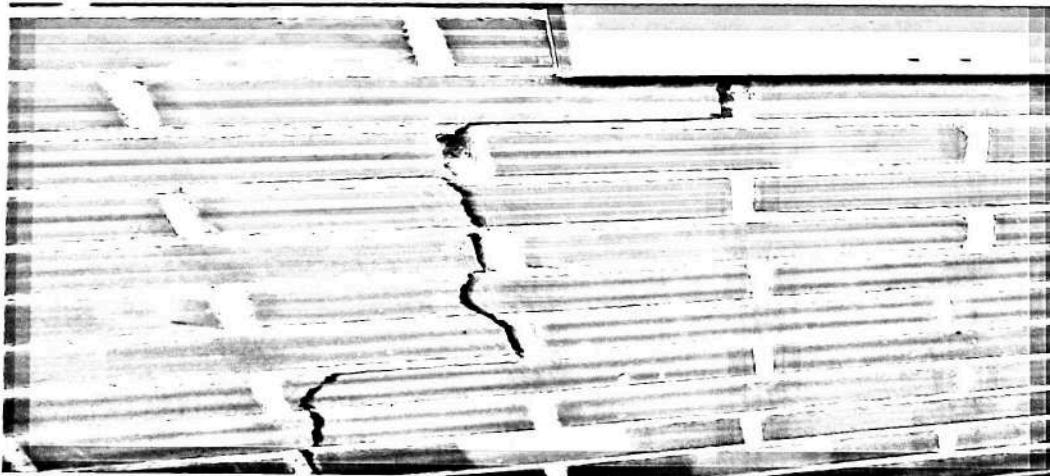
It was also noted during the inspection that a considerable amount of brick veneer had split and would require replacement. Due to the fact that over 70% of the cladding is damaged it would most likely require all the cladding to be removed and replaced as per attached photos.

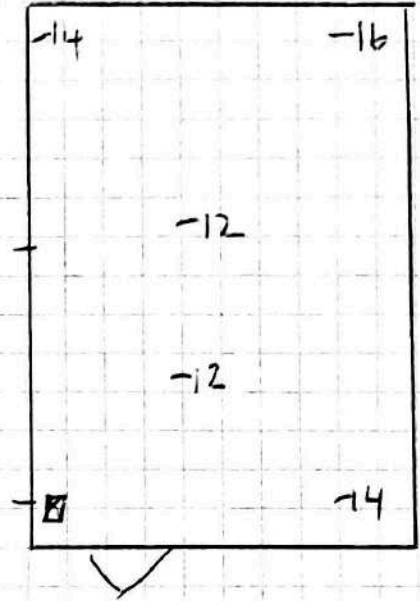
Garage F/L +/- 16mm

Maximum variation across the garage floor = 16mm +/- (<50mm MBIE criteria)

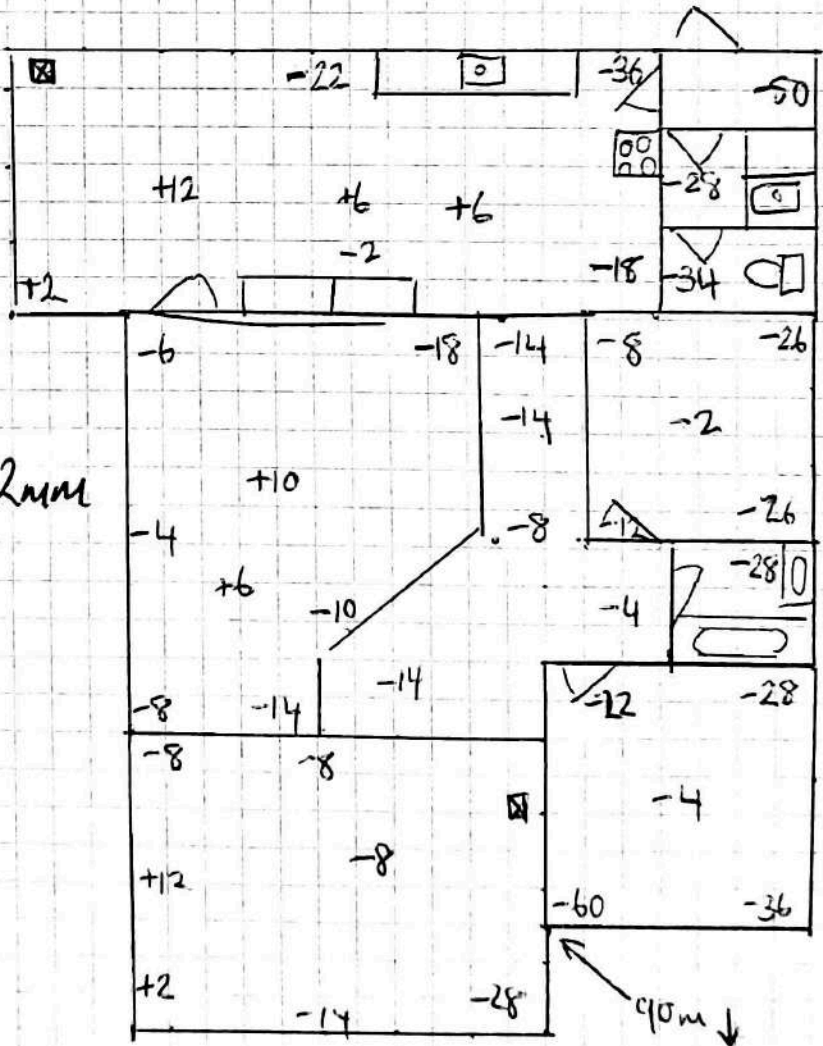
House F/L +/- 72mm

Maximum variation across the ground floor = 72mm +/- (>50mm MBIE criteria  
Relevel Necessary)

It was noted during the floor level survey that there are at least two areas in the ring foundation that had dropped and will require underpinning. These areas are the foundation corner by the rear door and the foundation corner by the sunroom.

MBIE guidelines note that any underpinning requires engineer's design. This will include the PS1 and PS4 from the engineer and a PS3 from an LBP registered builder for the works.

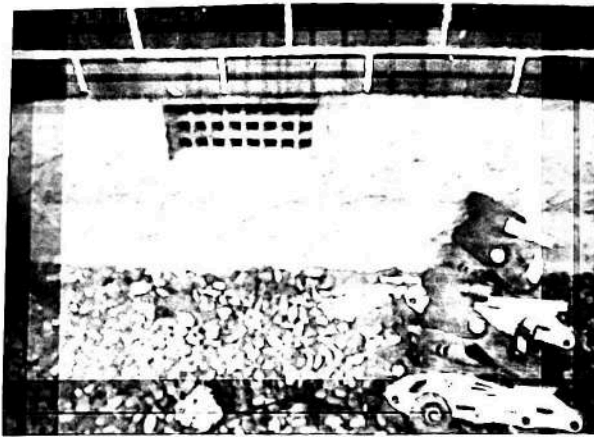
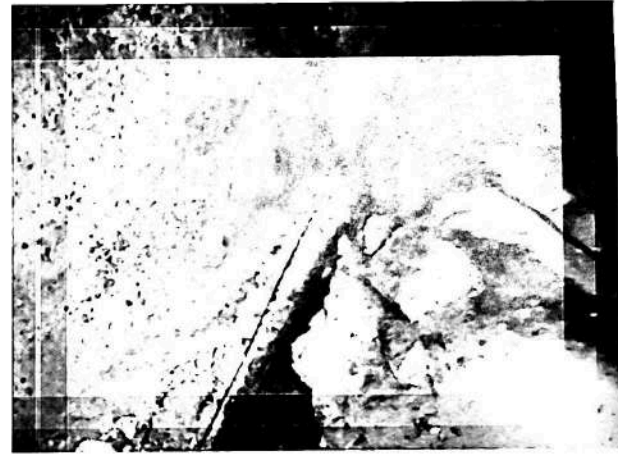
## Foundations

Concrete ring foundation with hairline cracks to all elevations generally around vents with minor spalling to plaster finish at South East corner. Vents are weak points in foundation wall and cracks require epoxy repair in conjunction with repairs to piles.

Suspended timber floor on concrete piles and timber sub floor framing. Pile to bearer connections are intact however due to Earthquake movement a number of piles require re-setting and packing to achieve pre earthquake levels, i.e general undulation to areas.

Floor levels were checked with a laser level and were within a variance of Approx 45mm generally lower to South East corner. Stress wrinkling of Vinyl in Dining/Kitchen noted.

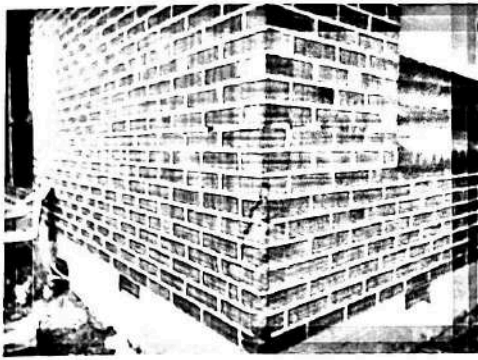
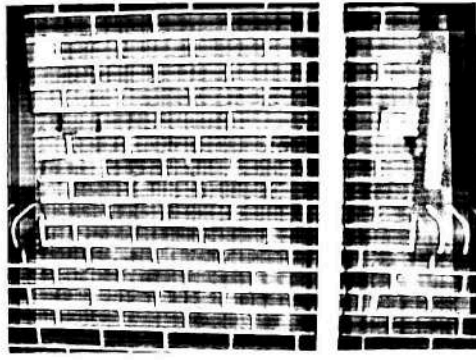
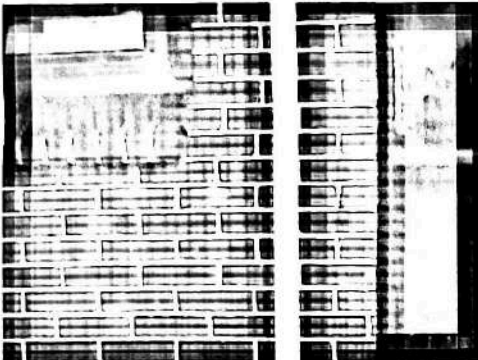
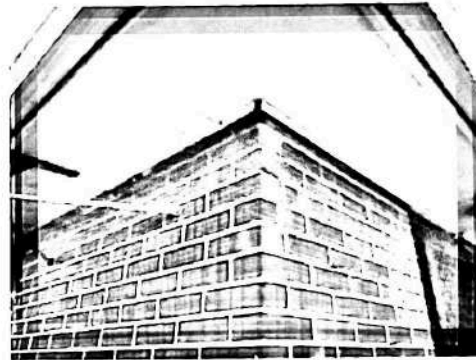
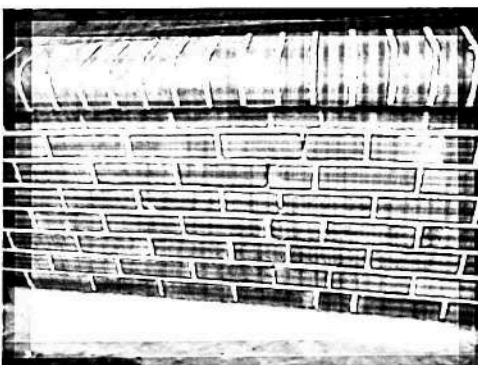
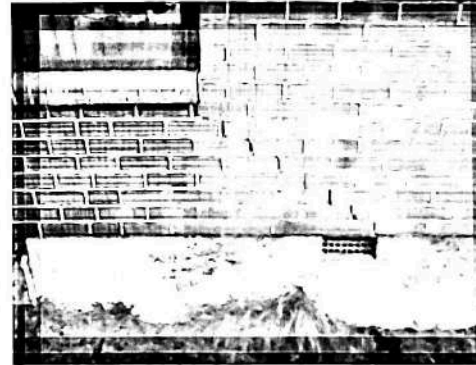
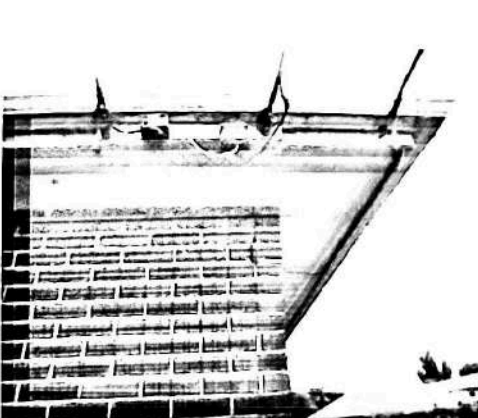
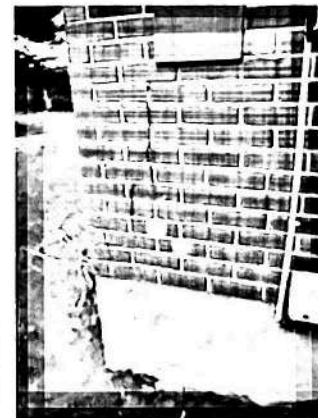
## Major cladding

Original red brick with stepped cracking observed to mortar joints at all elevations with approx 20 - 30 cracked bricks and displacement to some panels which has compromised brick ties. Due to displacement I believe panels to some elevations will require re-laying.

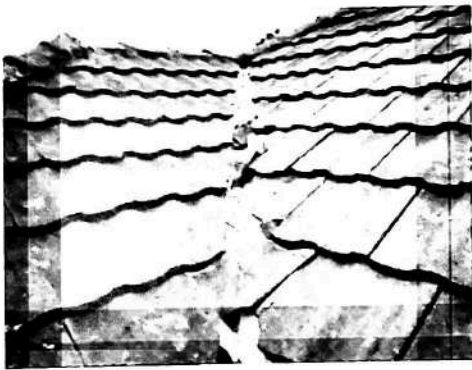
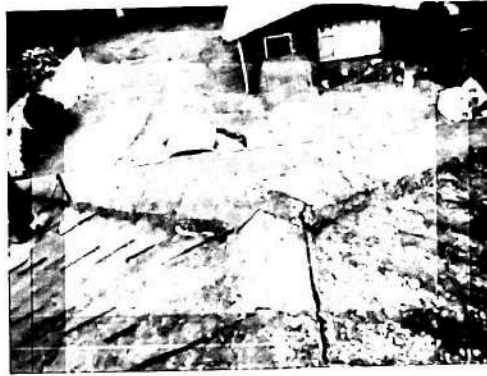
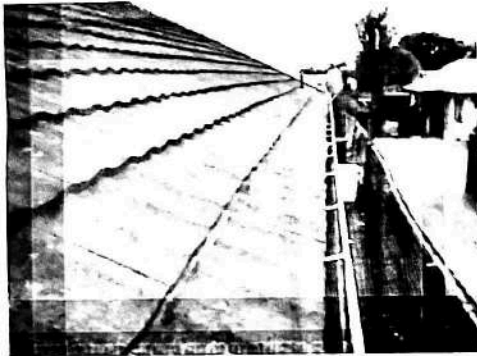
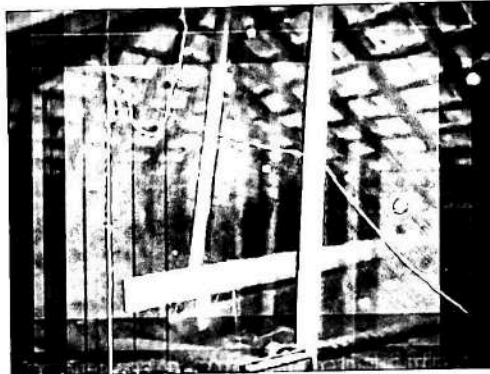
## Roof

Rafter framed roof clad with concrete tile. A number of displaced tiles observed in Valleys and to lower row on South elevation. These tiles require re-instating and re-tensioning wires to secure. Cracks to some areas of mortar on Ridge and Hip tiles, requires re-pointing to weather proof.

Detached flashing to pipe work protruding through cladding, requires repair.

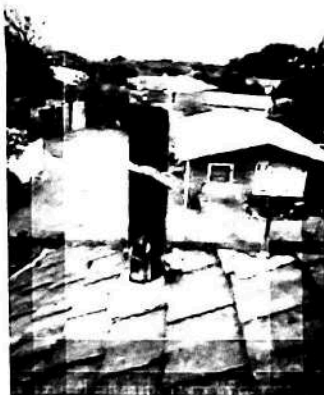
## Chimney

Metal flue with corrosion noted, concrete capping has detached and requires re-flashing to seal and weatherproof.

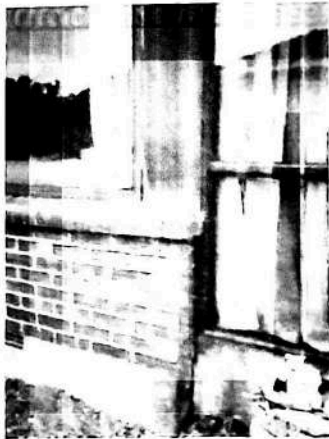
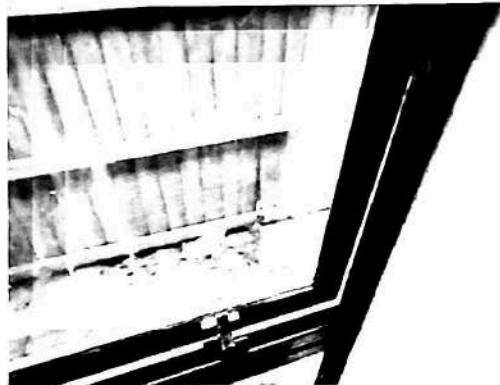
## Window Frames

Separation of window flashing to frame on Living room window alongside Conservatory due to displacement at foundation, wall requires repair to weatherproof in conjunction with repair to foundation pad supporting Conservatory.

Separation between frames and brickwork to a number of window openings with gaps visible, requires re-sealing, or flashing trim in conjunction with brick veneer repairs to prevent water ingress.

Security screen door on North East elevation is binding and requires adjustment to open and close correctly

A number of window opening sashes are binding in openings and require adjustment to clear and seal when shut.

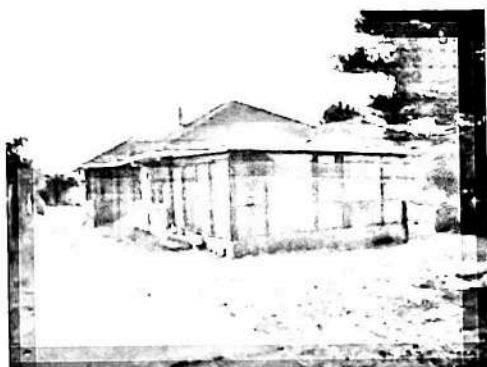
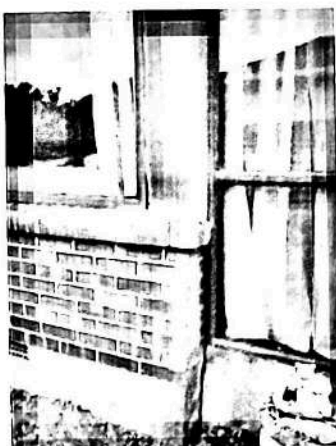
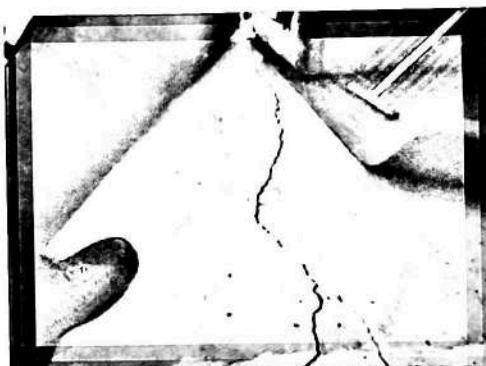
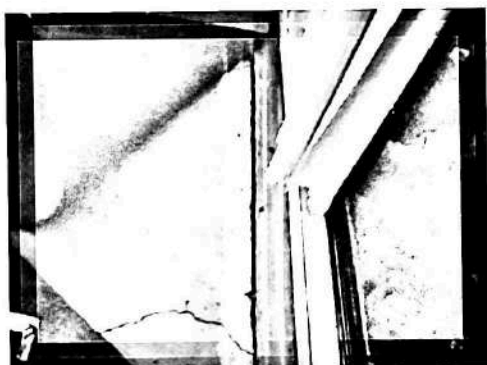
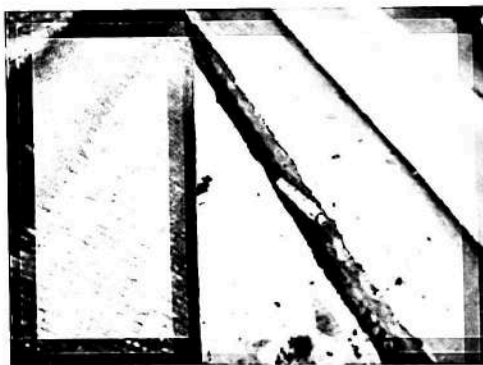
## Conservatory

Attached Conservatory, constructed approx 1996 over concrete pad foundation floor slab. Cracking noted to concrete floor and separation at Dwelling Foundation line in conjunction with slab dropping approx 40mm towards West elevation.

Separation of trim also noted to door reveal of internal sliding door, requires repair.

Slab requires repair/reconstructing to pre earthquake levels.

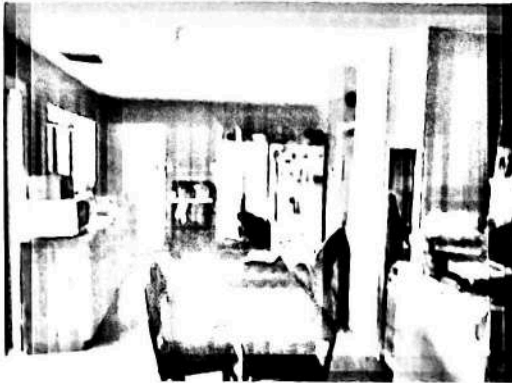
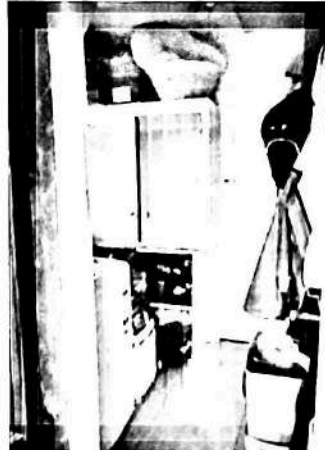
### **Kitchen/Living/Bathroom/Bedrooms**

Internal wall and ceiling linings have been recently re-stopped and re-painted in Living rooms and Bedrooms. Original wallpaper in Laundry with cracks observed under paper at door and window openings and wrinkling of paper to internal corners. Requires repair prep and repainting in conjunction with future redecoration.

Leak to Bath water pipe feeds in Bathroom may be earthquake related as leak appears to have been consistent for some time, requires repair. Water damaged Gib board at head of Bath requires replacing.

Separation to some timber trim - requires re-fixing, prep and repainting.

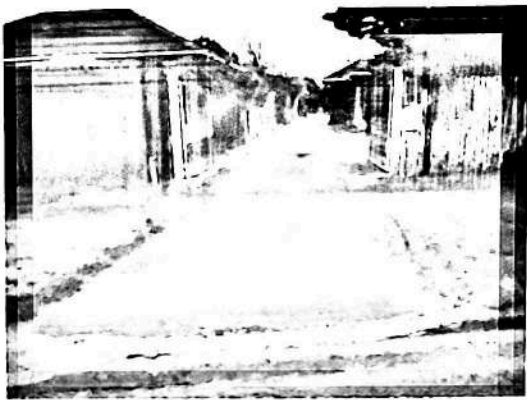
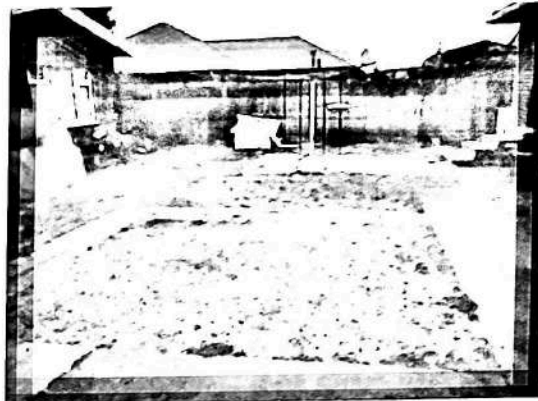
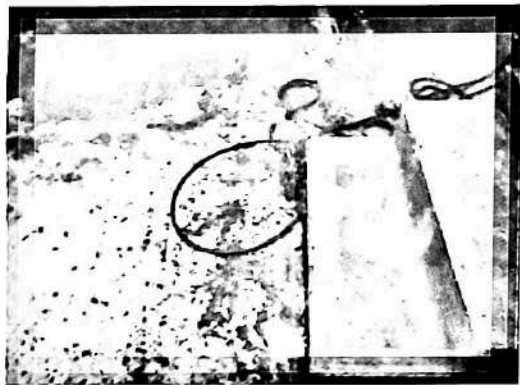
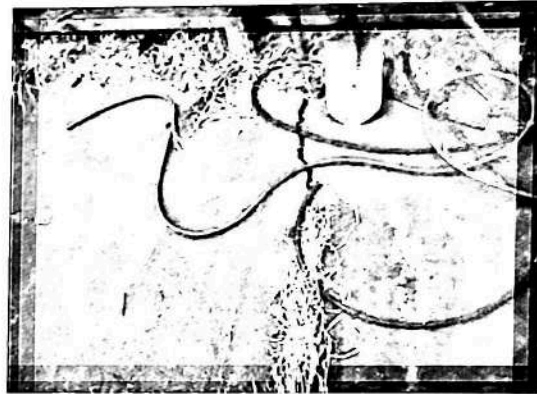
## Drive / Paths

Original concrete Drive with historic cracks which have been accentuated by earthquake movement.

Separation to steps and cracks to Paths noted.

I recommend repair/replacing.

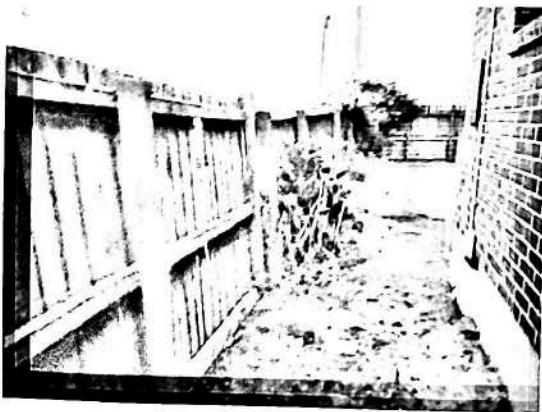
## Fencing

Earthquake ground settlement/movement has resulted to leaning and dropping of East boundary fence, I recommend re straightening repair.

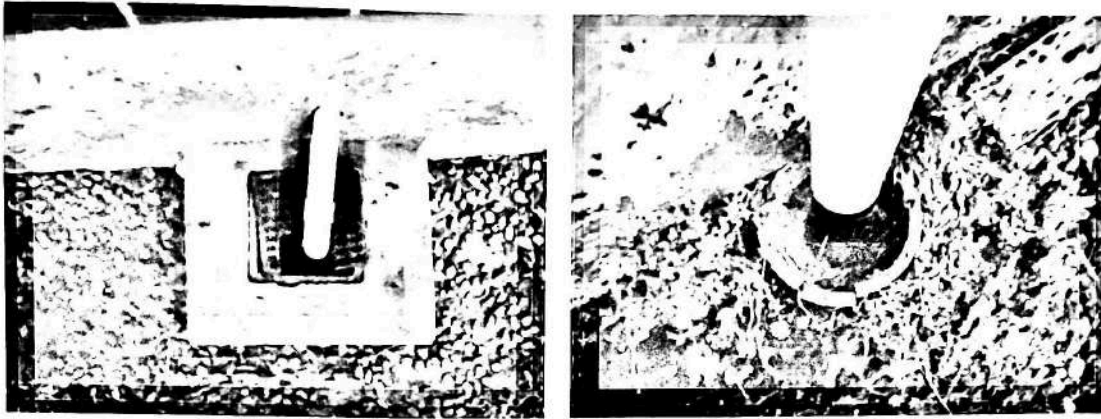
## Stormwater/Drainage

Blocked stormwater outlet on North elevation, requires clearing. Due to earthenware pipes installed and earthquake movement, I recommend having underground pipes CCTV video inspected for damage/leaks etc.
